Turbo removal Install, Removal and Exhaust Back Pressure Valve Removal

Part I: Refers to removing the Turbo/pedestal to check/fix oil leaks,

Part II: EBV gutting procedure is down at the bottom.

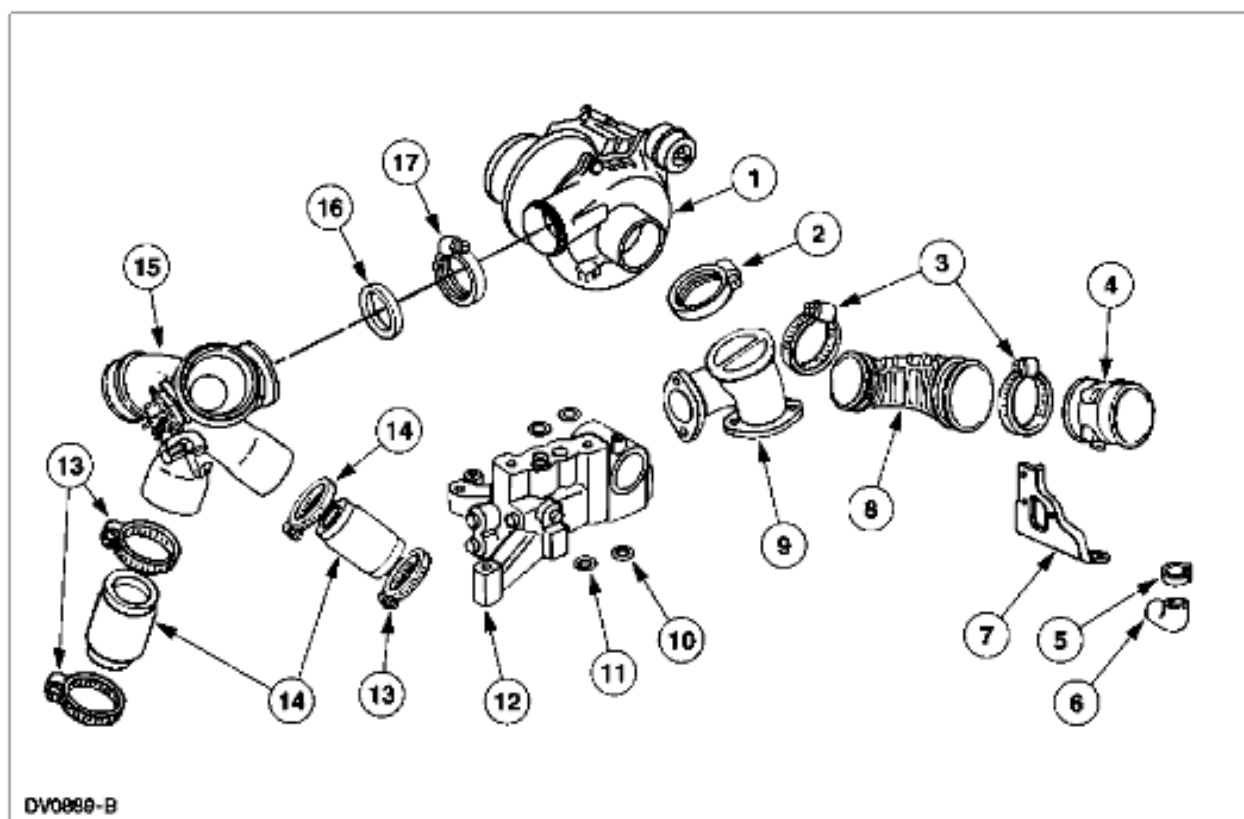
Item Part Number Description

1	6K682	Turbocharger
2	8287	Marmon Clamp
3	8287	Clamp
4	1820052C92	Air Inlet Duct
5	1813366C1	Breather Hose Elbow Clamp
6	181603022	Breather Hose Elbow
7	6K864	Air Inlet Bracket
8	9C681	Air Inlet Hose
9	6K854	Turbocharger Exhaust Inlet Manifold
10	6N653	Turbocharger Oil Supply O-Ring (2 Req'd)
11	6N653	Turbocharger Oil Drain O-Ring (2 Req'd)
12	6N639	Turbocharger Pedestal Assy
13	8287	Clamp
14	6C640	Intake Manifold Hose (2 Req'd)
15	6K889	Compressor Manifold
16.	9E436	Turbocharger Compressor Outlet Seal
17.	8287	Marmon Clamp

Remove the intake hose that runs from the air filter to the Turbocharger inlet. Make sure and remove the small sensor tube plugged into the side of the intake hose. To make it easier to remove the hose, unbolt the "air Inlet bracket" (figure 7 in the above diagram).
